**DRAFT FINAL
Environmental
Baseline
Survey Report**

**St. Louis
Army Ammunition Plant
St. Louis, Missouri**

Date Prepared	:	March 17, 2000
Tetra Tech Project No.	:	G0011-0054KRP02
Prepared by	:	Tetra Tech EM Inc.
Tetra Tech Project Manager	:	Michael Barlage
Telephone No.	:	(312) 856-8700
U.S. Army Aviation and Missile Command Project Manager	:	Valerie Shippers
Telephone No.	:	(256) 876-0211

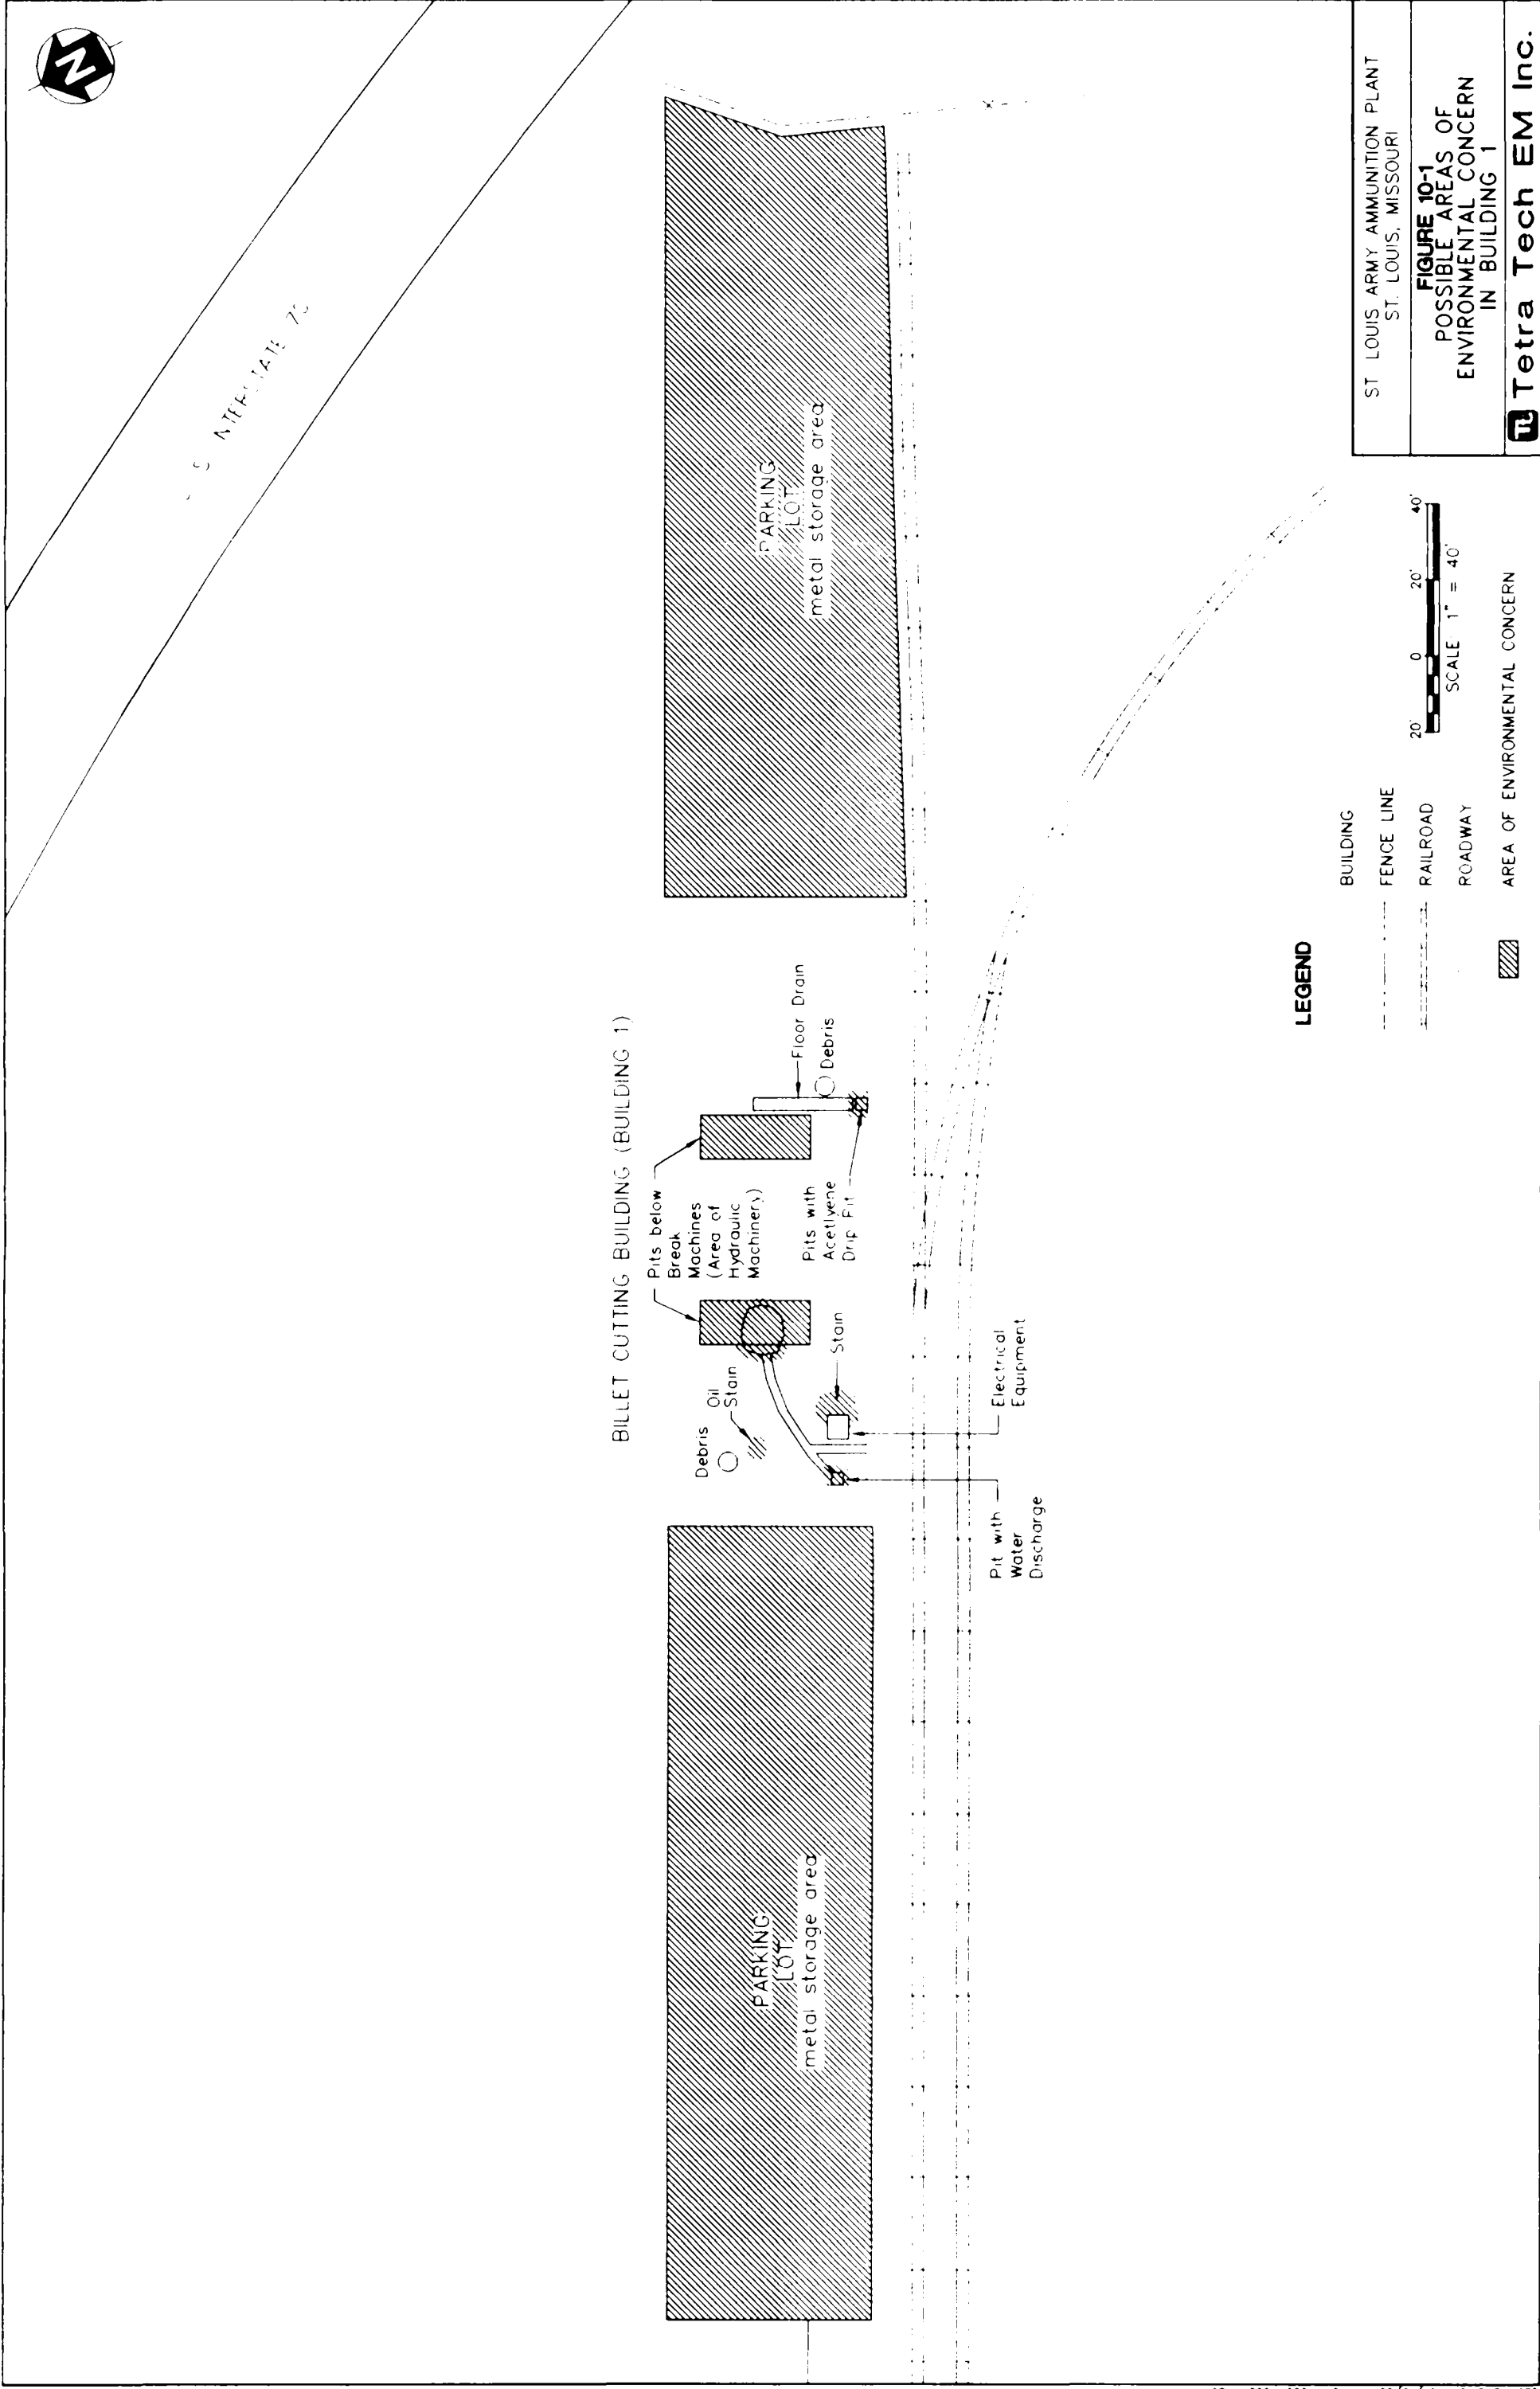
The following possible areas of environmental concern were identified in Building 1 (see Figure 10-1):

- Because of the age of the electrical equipment, it may contain PCB oil.
- Debris was present throughout the building.
- Spilled oil was identified in the building.
- Concrete-filled hydraulic oil pits, sumps, and floor drains were identified.
- Two pits connected to the sewer system were observed.
- Outdoor metal storage areas were identified.

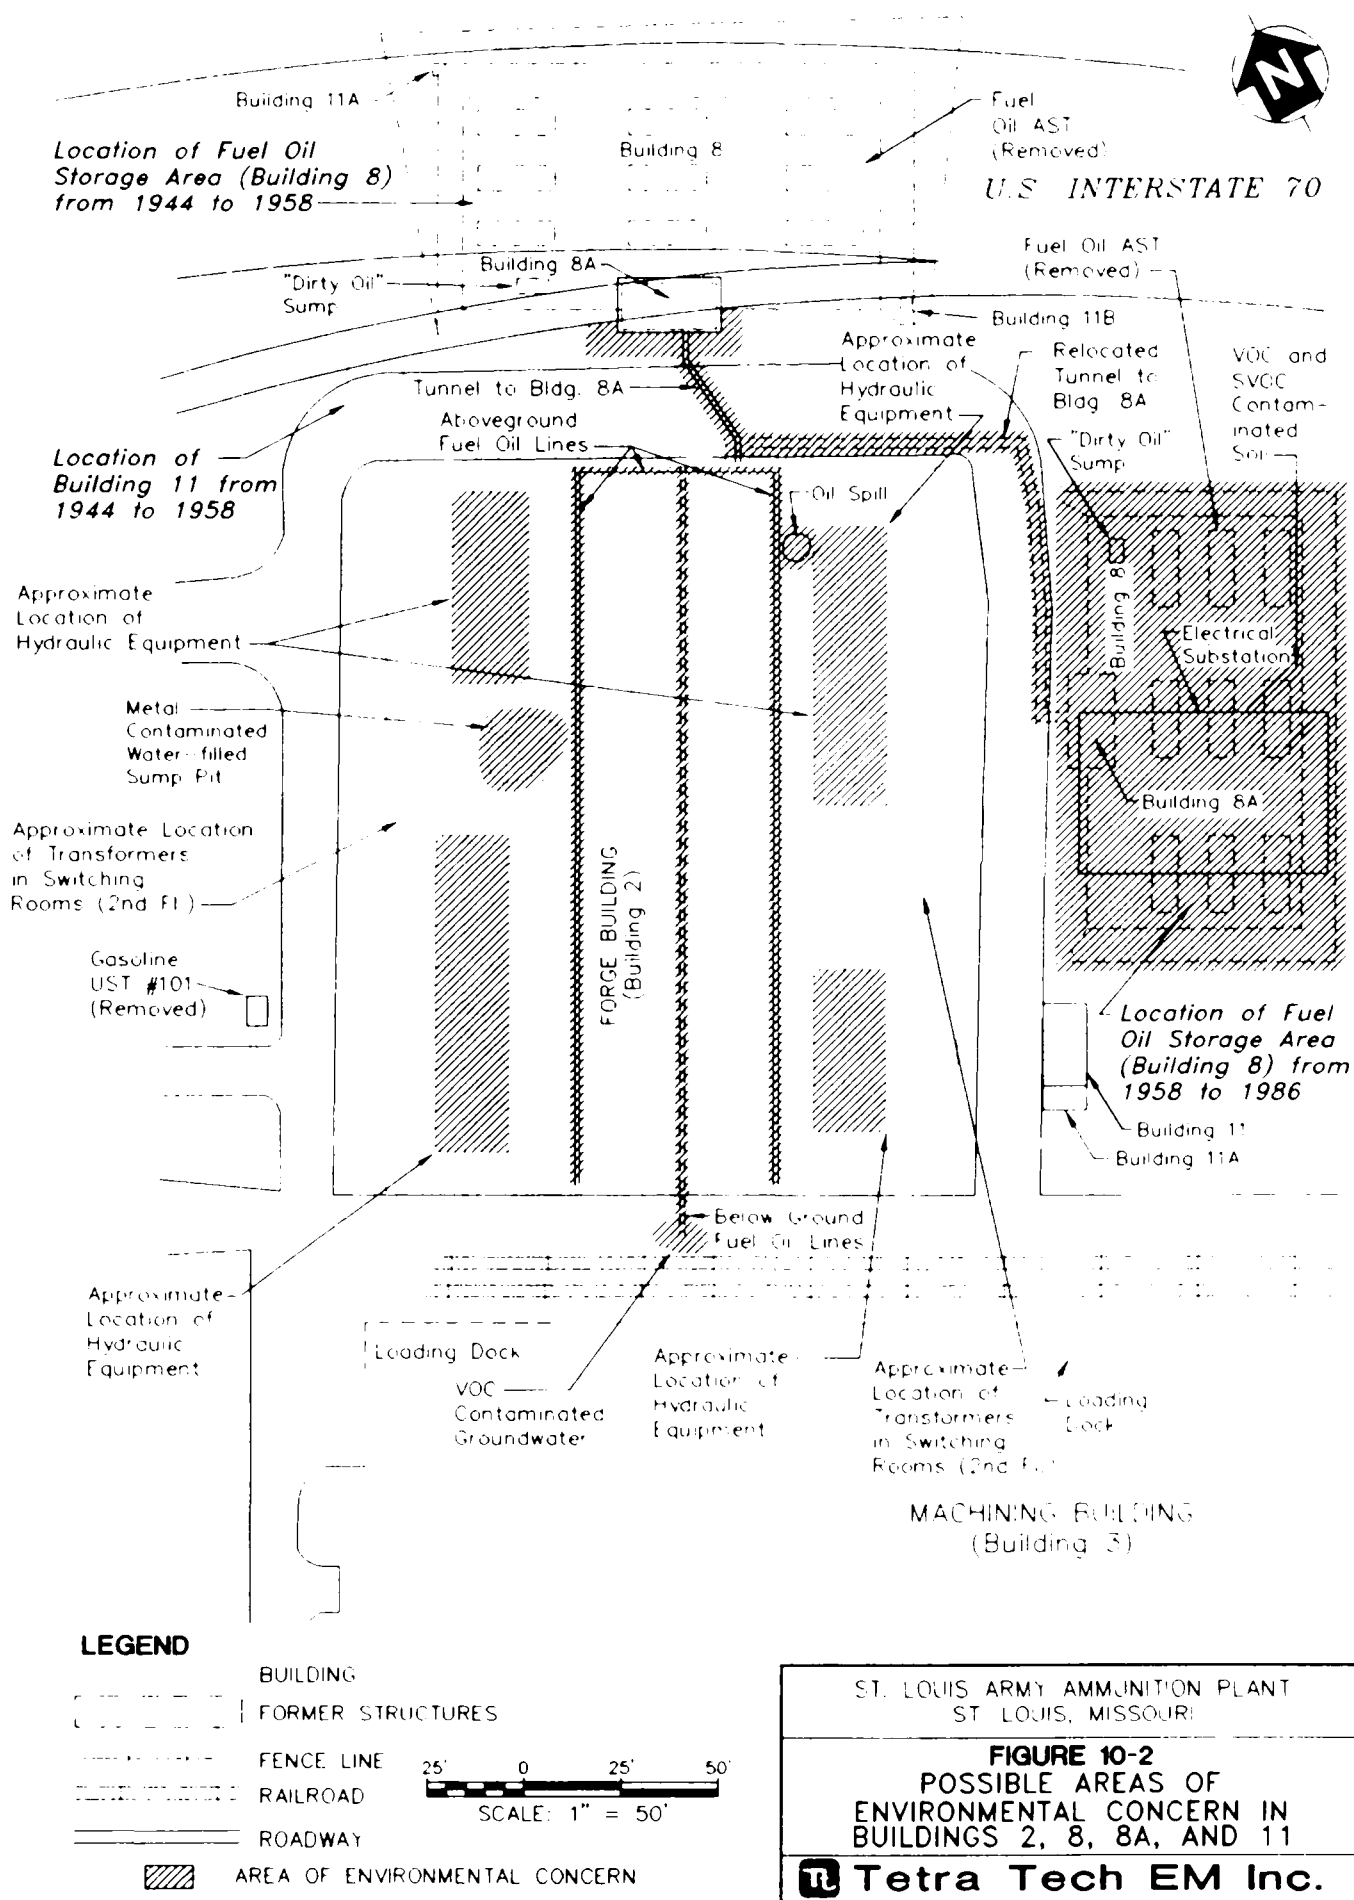
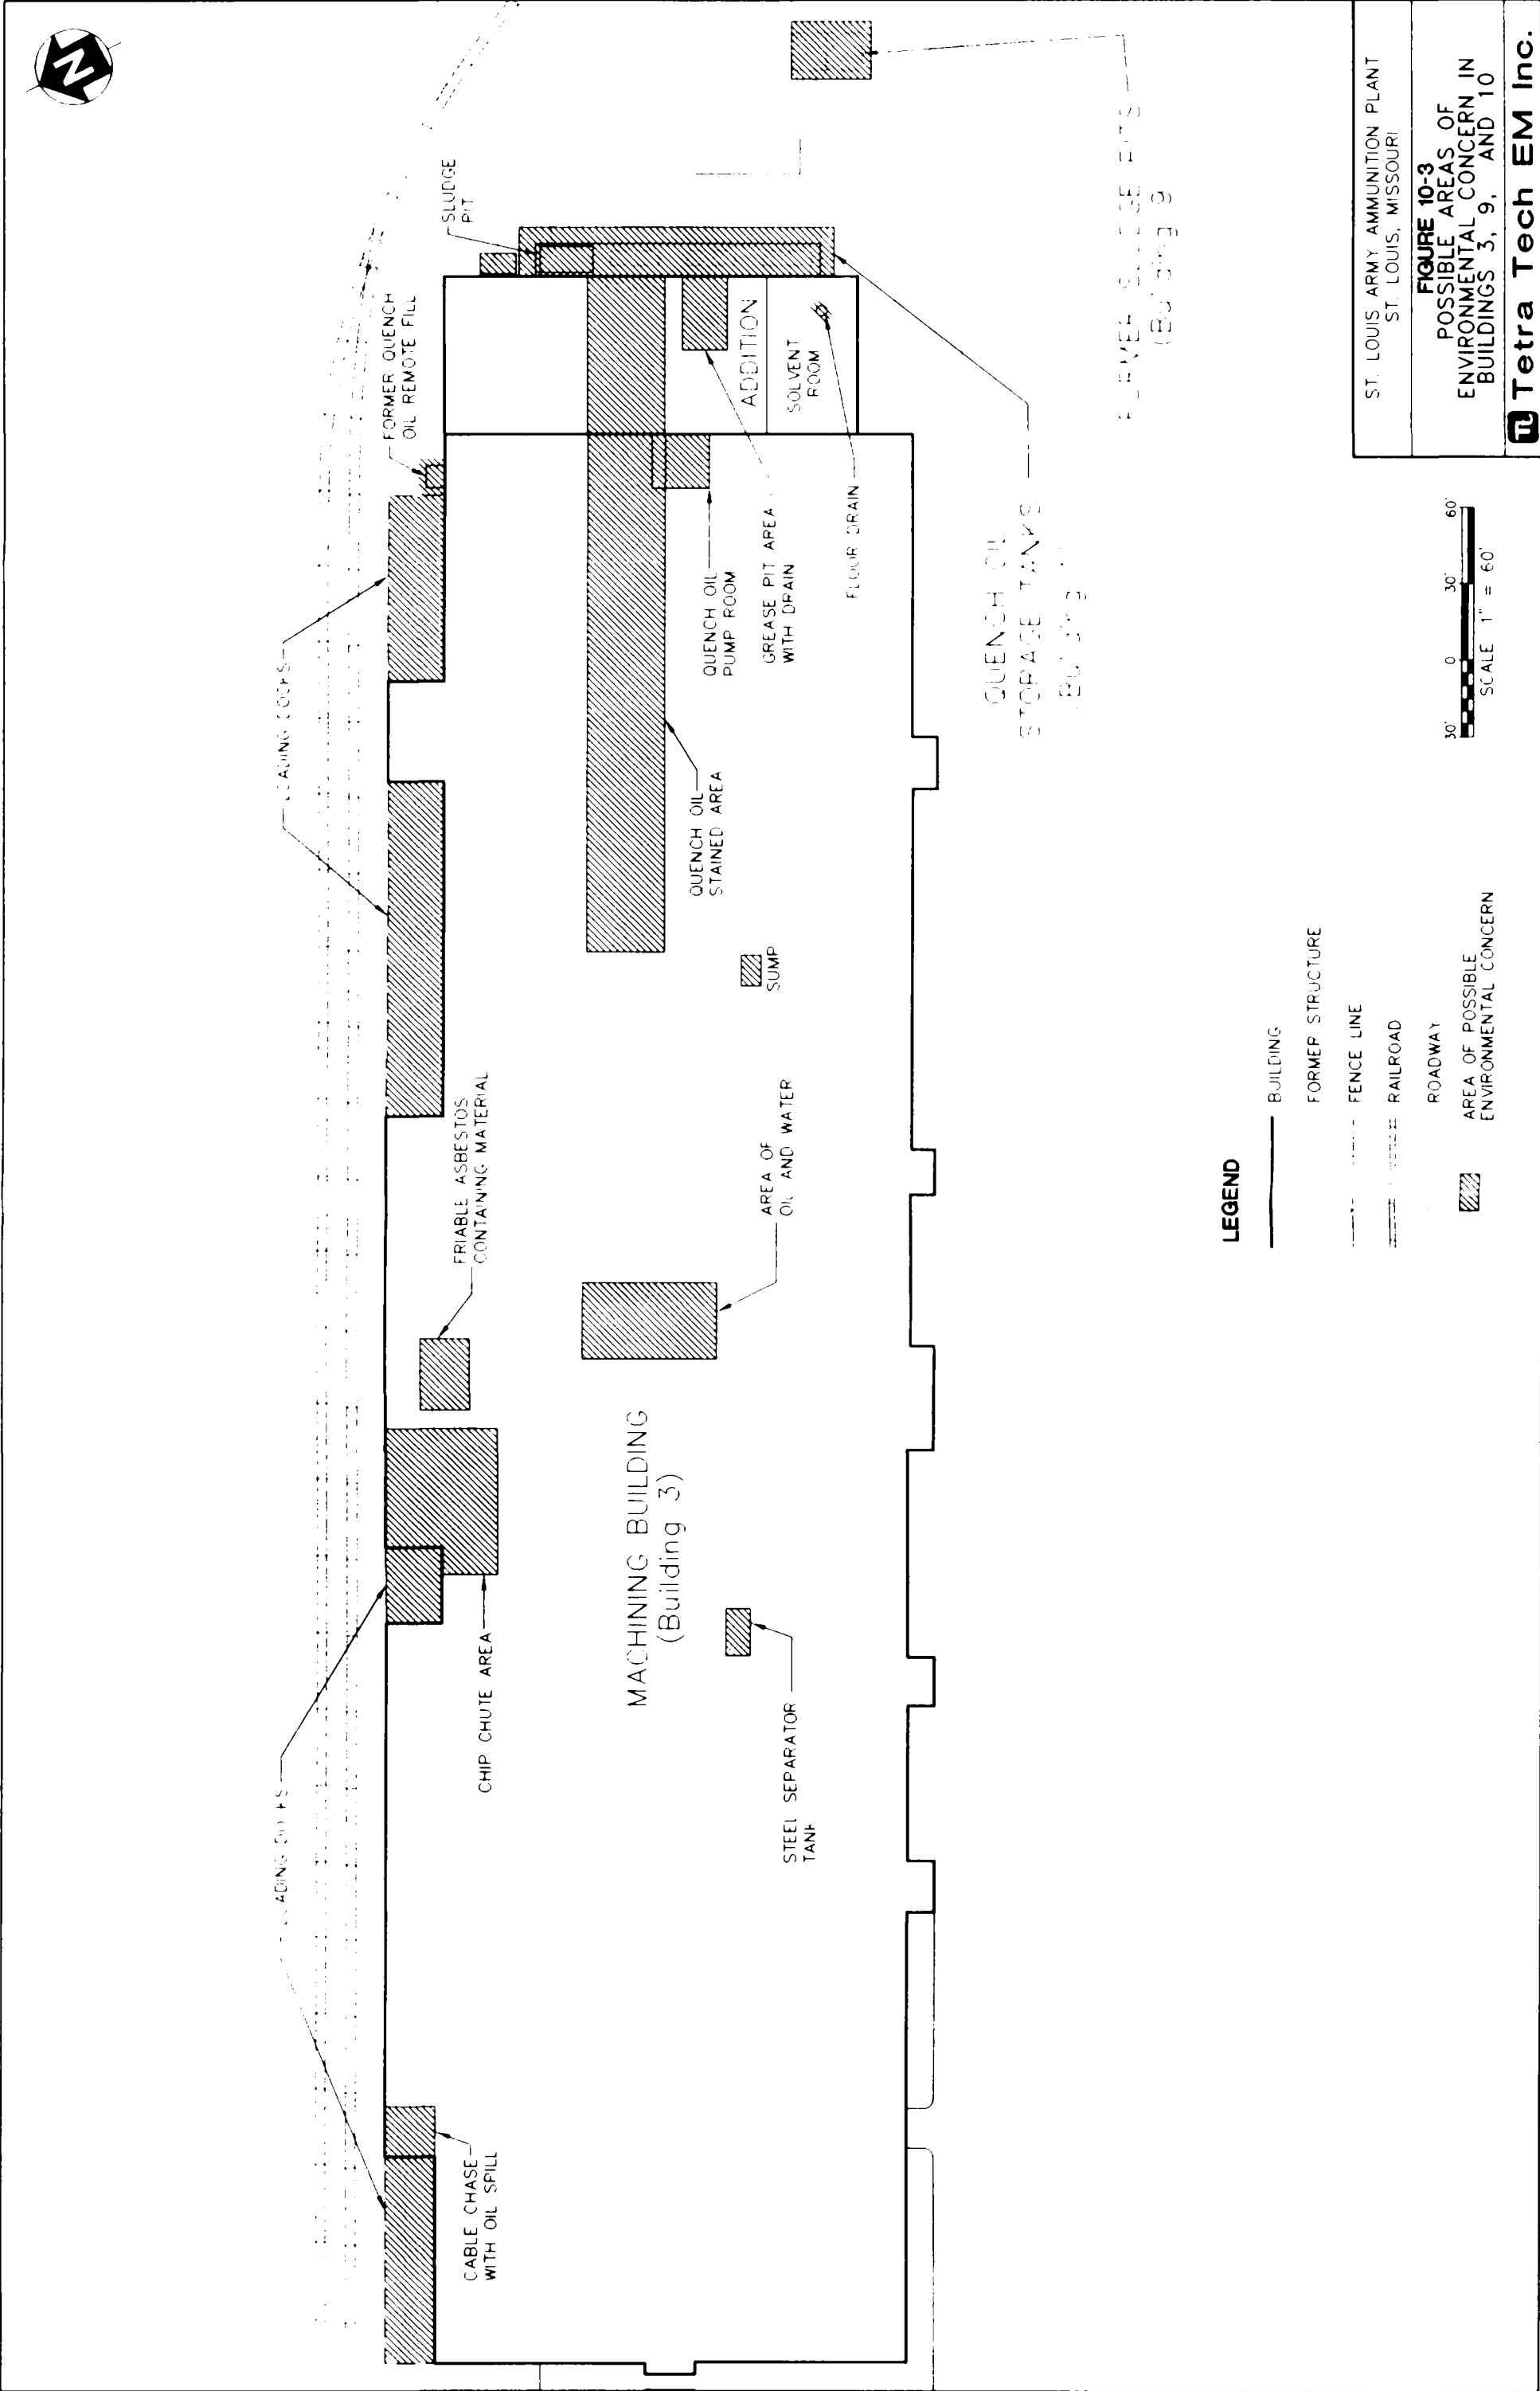
10.2.2 Building 2: Forge Building

The following possible areas of environmental concern were identified in Building 2 (see Figure 10-2):

- PCB- and pesticide-contaminated soil may be present in the former chip chute area in the basement.
- Oil staining was present along the far east foundation wall, on the floor, and on support columns in the vicinity of the quench oil pump room in the basement.
- Friable ACM-like material and metal shavings potentially contaminated with PCBs were observed on the basement floor.
- Oil was found floating on top of water on the floor in the central portion of the basement.
- A steel separator tank was identified in the south-central portion of the basement. The tank was filled with a dried, oxidized material that may be of environmental concern.
- The former transformer vault in the northwest corner of the basement contained spilled oil. This oil may contain PCBs.
- Water was identified in one sump in the basement.

- Cracks in concrete caps were observed on the first and second floors.
- Paint used to seal the steel structures on the first floor was cracking and peeling.
- A solvent area was identified in the Building 3 plans. The solvent area drain was attached to the sewer system, and water was identified in this drain.
- Fluorescent light fixtures that may contain PCB-containing ballasts were identified in a room on the first floor.
- A room on the second floor contained an emergency power supply unit. This unit may contain lead-acid or nickel-cadmium batteries.
- Spilled oil from leaking motors was identified in each of the penthouses. The oil may contain PCBs.
- A remote quench oil fill-pipe was located near the northeast corner of Building 3.

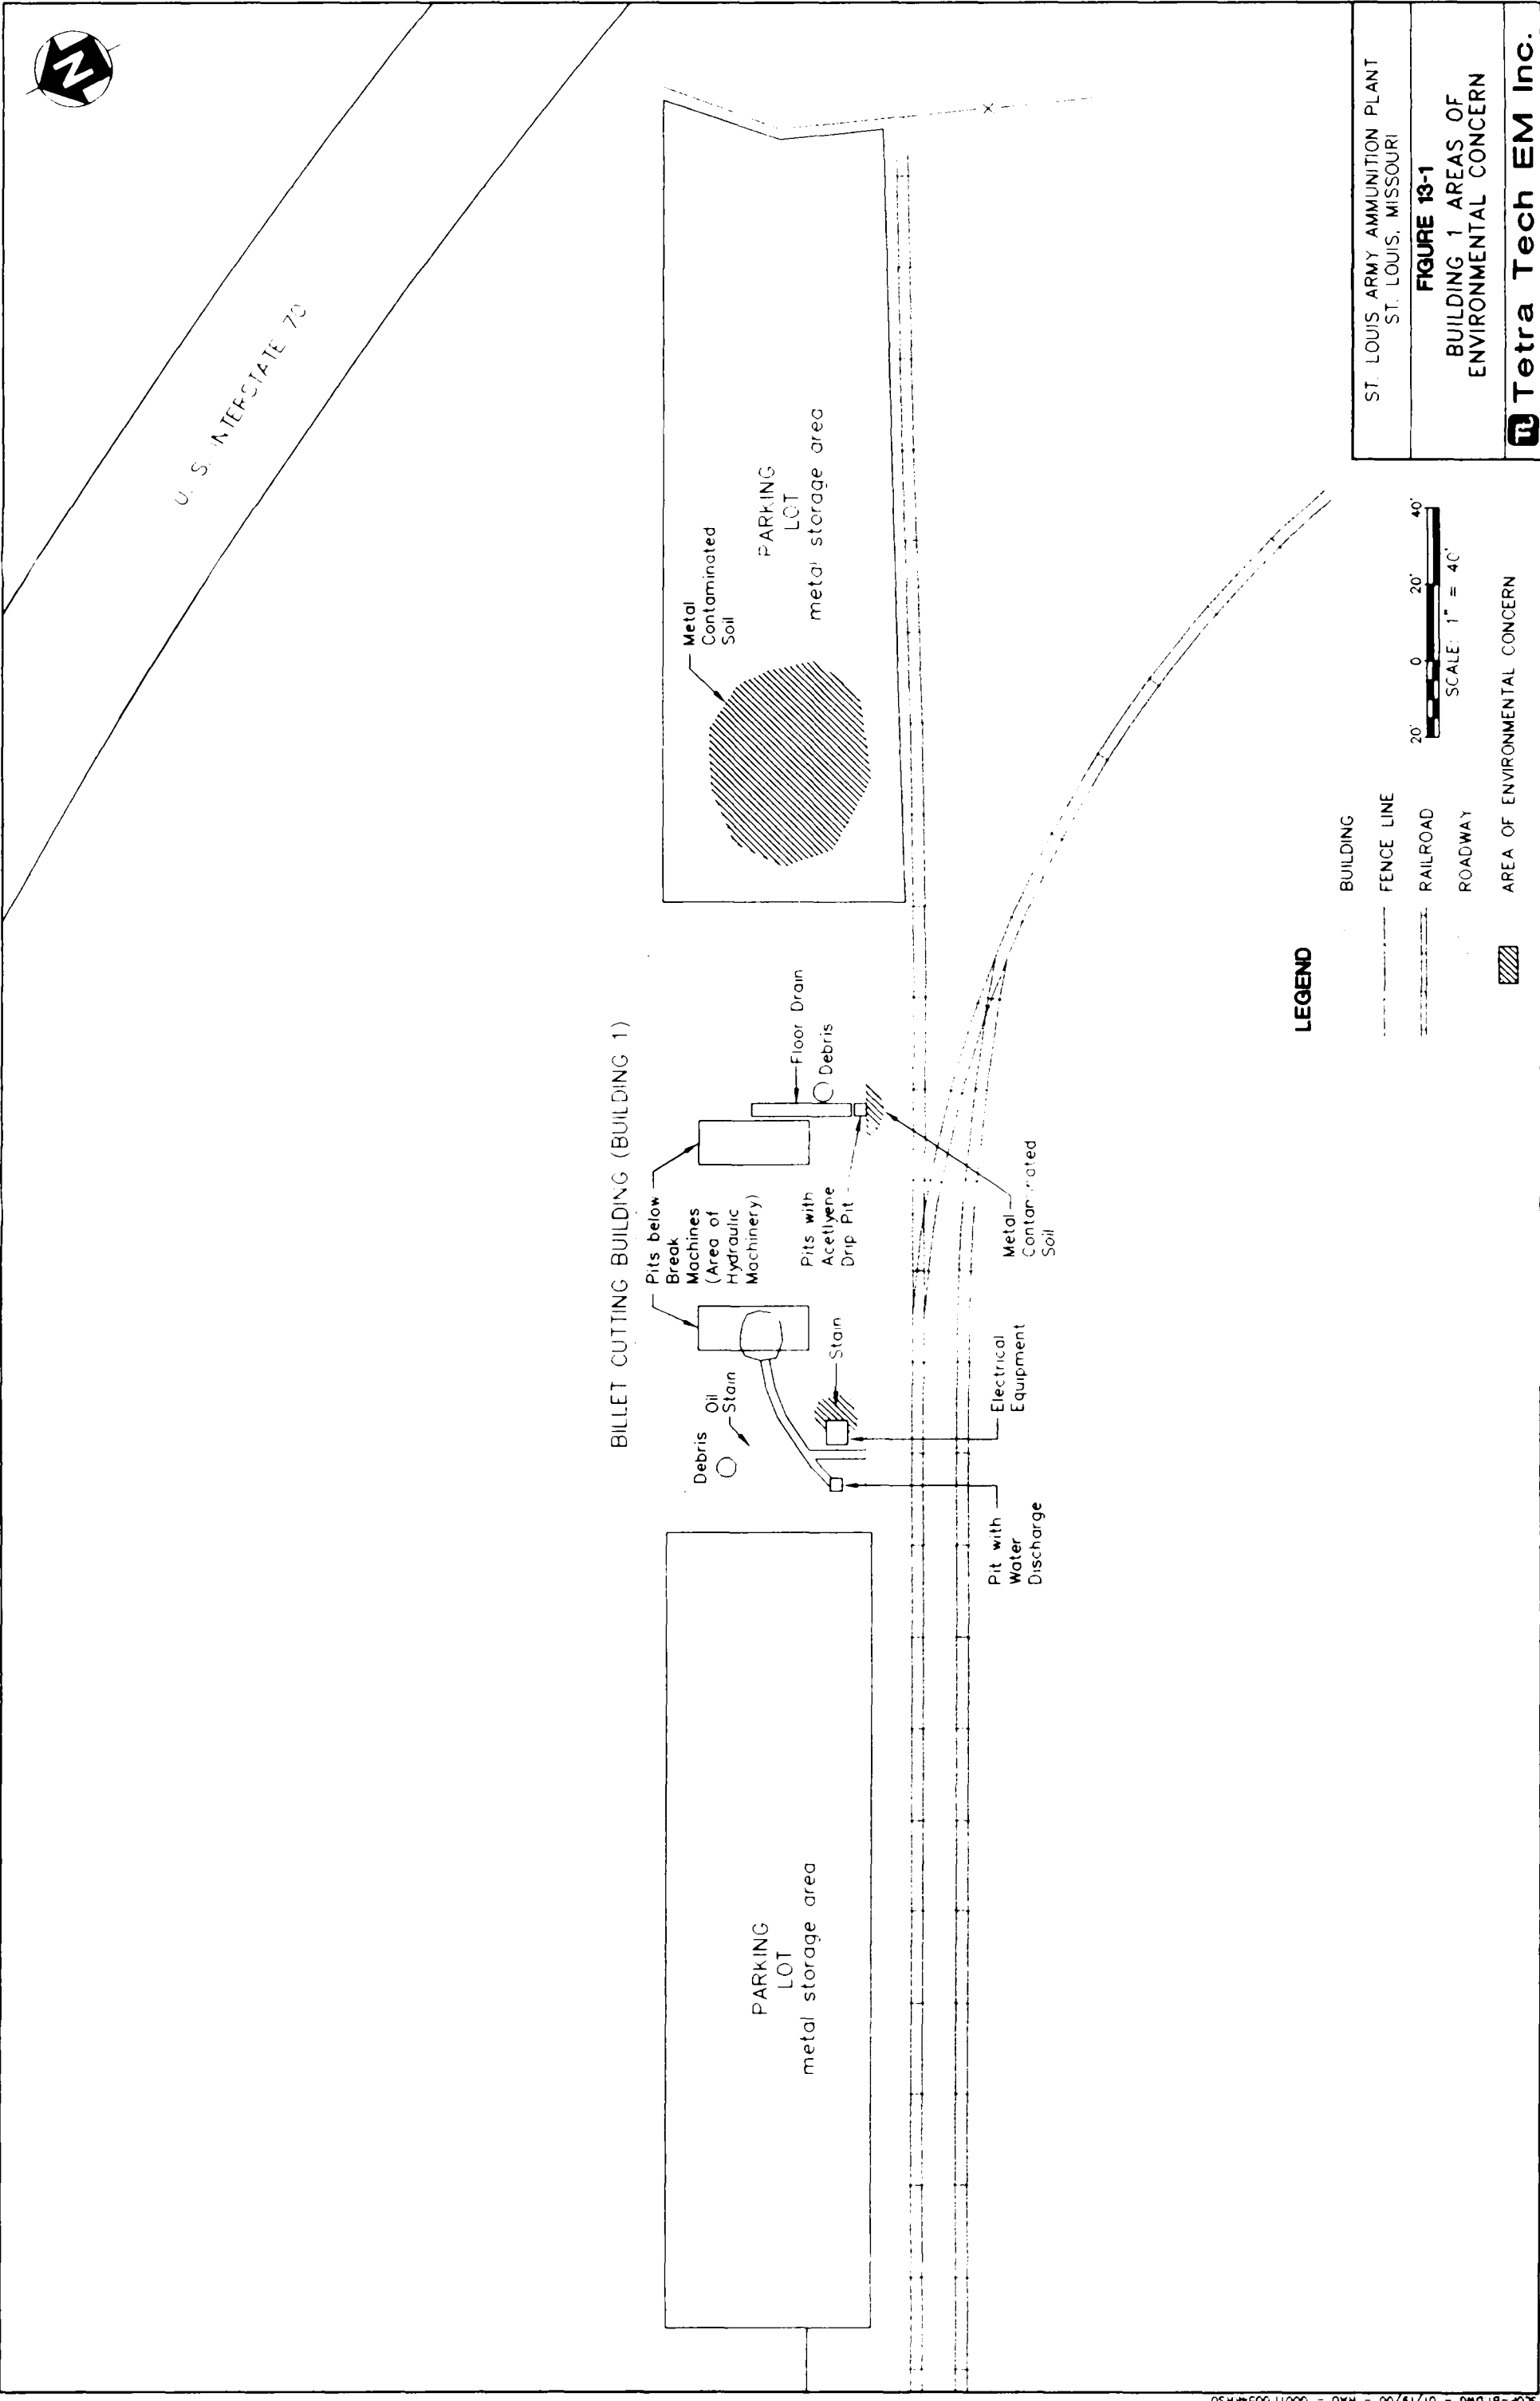
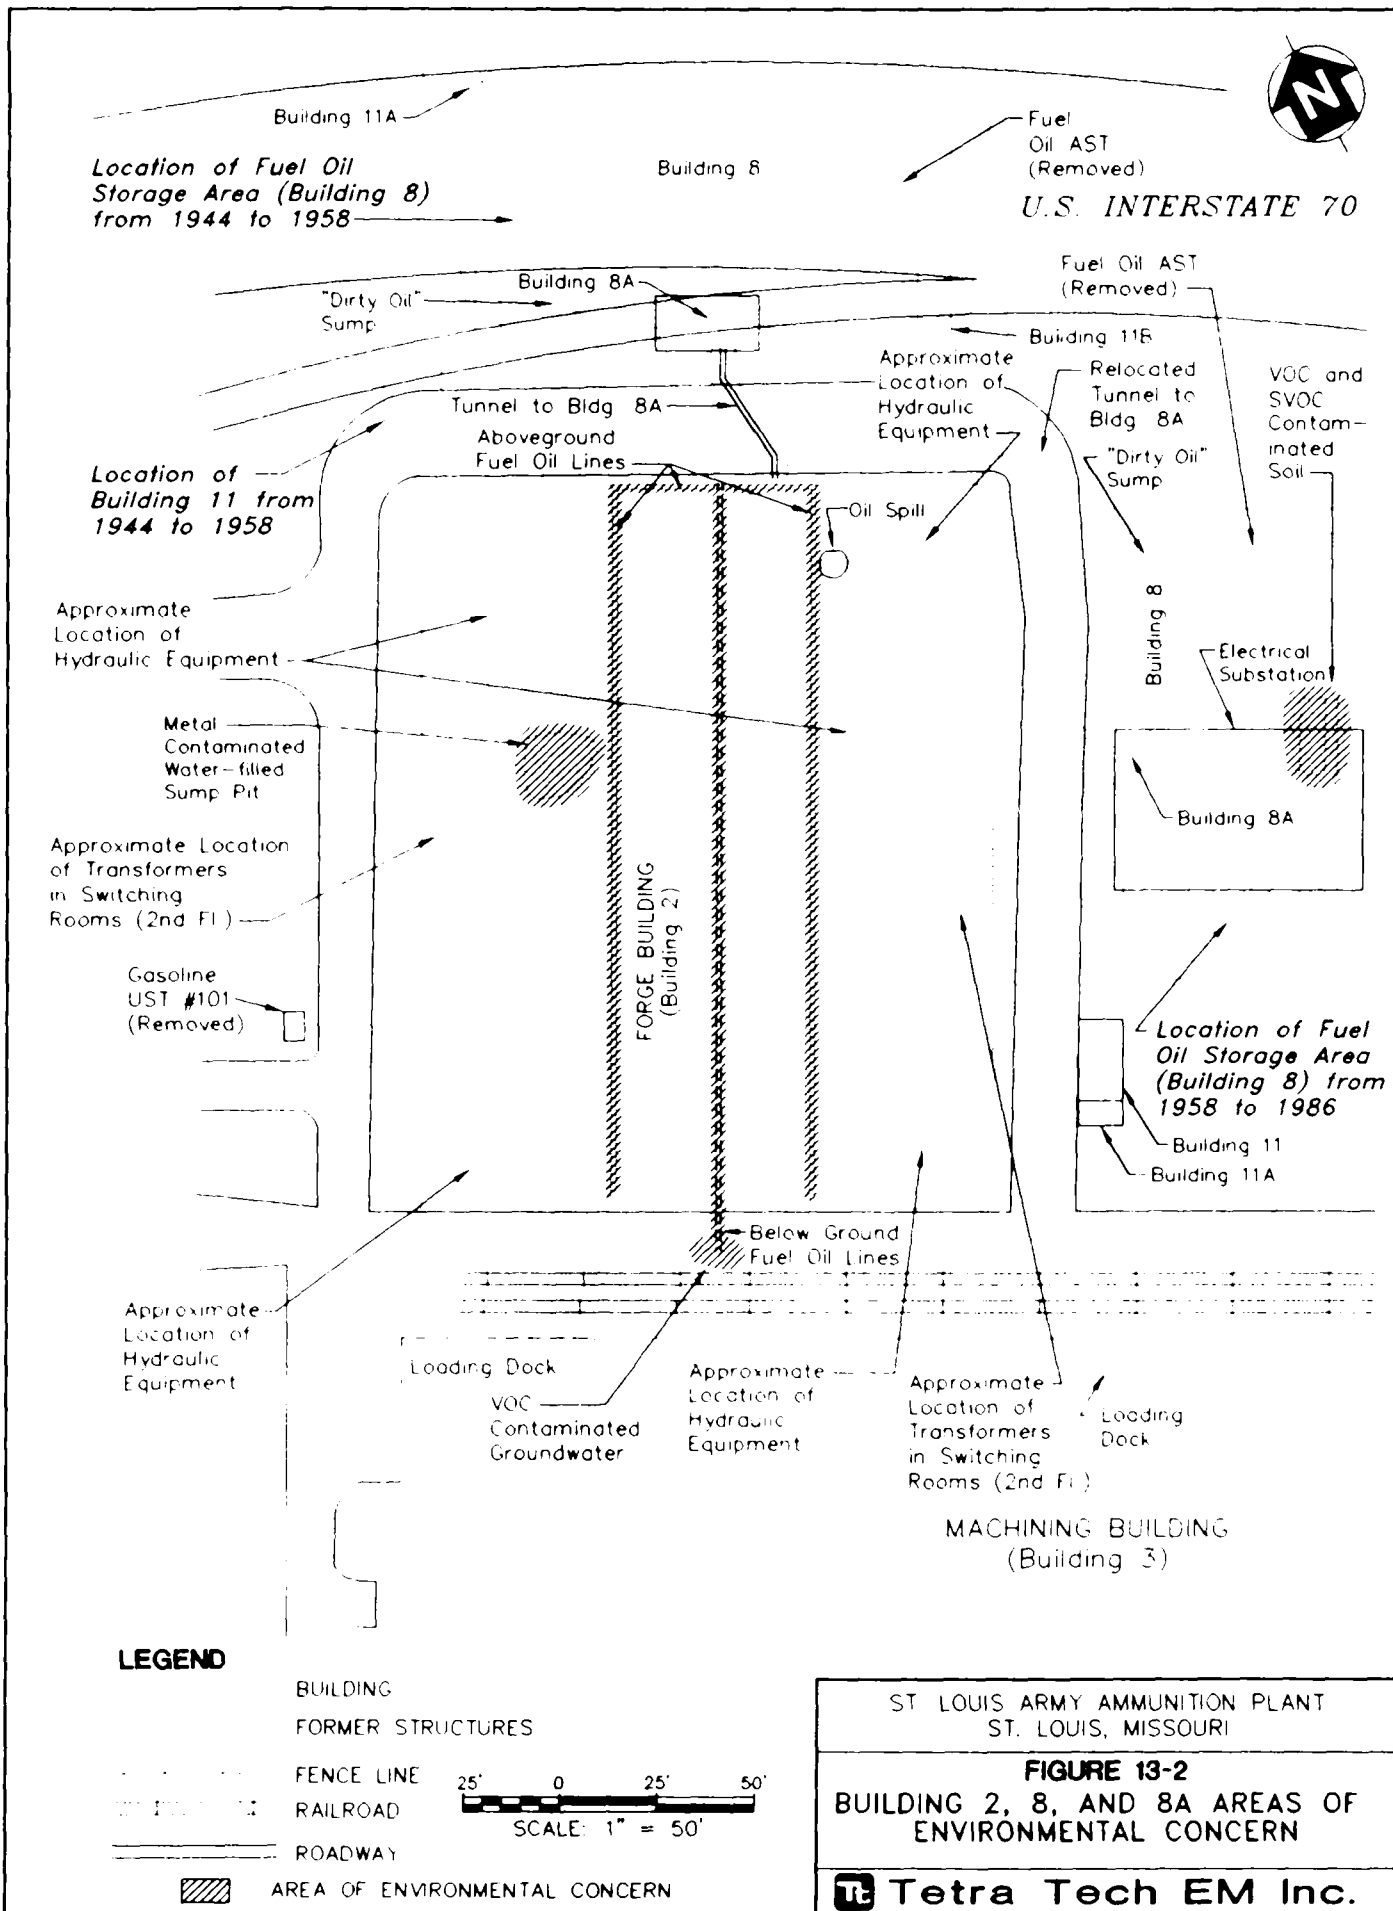
13.2.2 Building 2 Conclusions and Recommendations

EBS investigation activities completed at Building 2 included completion of one monitoring well and collection of two surface soil samples, one wipe sample, two sump water samples, and groundwater samples. The surface soil samples contained metal concentrations exceeding CALM criteria. Therefore, the soil material in the building appears to pose an environmental concern. This area of environmental concern is depicted in Figure 13-2. The soil material should be analyzed for waste characterization parameters and then properly disposed of. The wipe sample collected from the oil stain did not contain PCB concentrations exceeding CALM criteria. Therefore, the oil stain does not appear to be hazardous and does not pose an environmental concern. The groundwater samples collected from the monitoring
